# Roping Chute

## Troubleshooting Guide

**RC98A - RC98AI - RC98SCORE - RC98Q36**

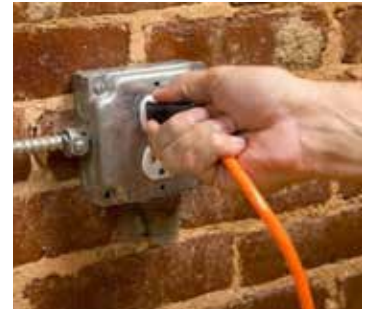
### Step 1 – 110VAC Electrical Connection:

Check Power source. Be sure that sufficient current is available and that the breaker/fuse is good. Check outlets and any extension cords used in the connection. If there is power to the Control Box, the GREEN indicator light will be illuminated.

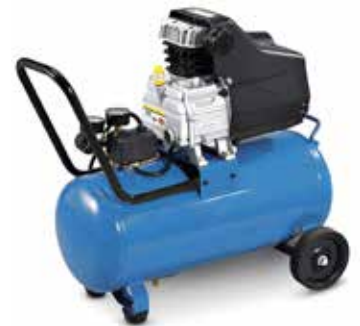
### Step 2 – 90psi Compressed Air Supply:

Check to be sure that the compressed air line is connected properly to the back of the control box. Proper performance requires a minimum of 2hp air compressor that will produce 3.1 cfm at 90 psi, with a 4 gallon tank.

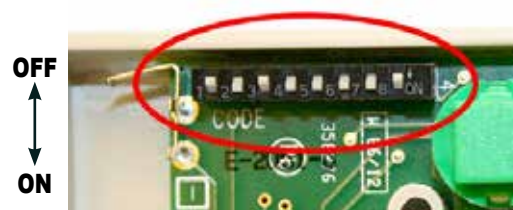
*TRANS2001 Dip Switches*

If you only have a single remote remove the back as if you were going to change the battery. You will see 8 small dip switches. Start with number 1 and flip it like you are turning a light switch off and right back on. Do this with all eight dip switches. In other words, each switch will need to be reset. Occasionally, one of the switches will toggle loose and need to be reset when in fact it looks perfectly normal.

**Note:** The factory code is set to 1,3,8 off (away from the numbers) 2,4,5,7,8 on (toward the numbers)

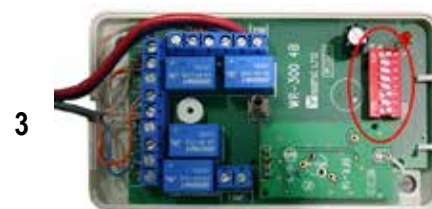
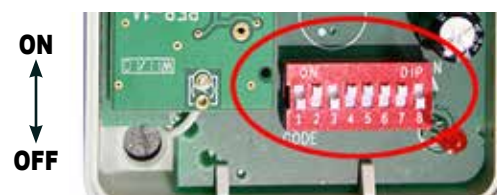
*REC2001 Dip Switches*

3. The receiver (*REC2001*) located on the heeler side of the control box may need to have the dip switches reset as well. As in the transmitter, the receiver codes will need to be reset in the same manner. Start with number 1 and work your way to number 8 by flipping to dip switch in the opposite direction and right back to its original position.

**Note:** The factory code is set to 1,3,8 off (toward the numbers) 2,4,5,7,8 on (away from the numbers)

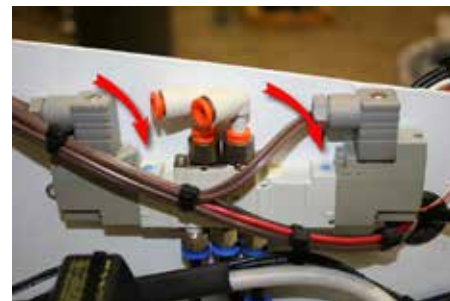
Manual Buttons SY5420-6D-N7T

1. Make sure the compressor is connected and working properly.
2. We can eliminate this being an air issue by pressing the manual buttons located on the top of each air valve as shown in the pictures on the right.

By pressing these buttons it forces the air valve to function. If the valve will not operate by pressing the button, simply back track your way from the valve to the compressor checking for restricted airlines or lack of airflow from the compressor.

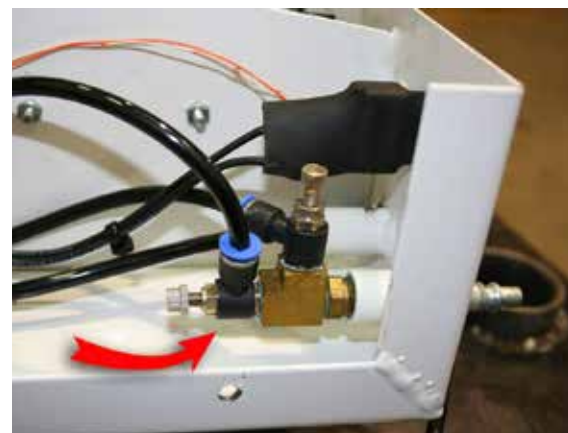
Control Valve

3. The control valves may need to be removed and cleaned of debris. The small holes in the control valves may become clogged.

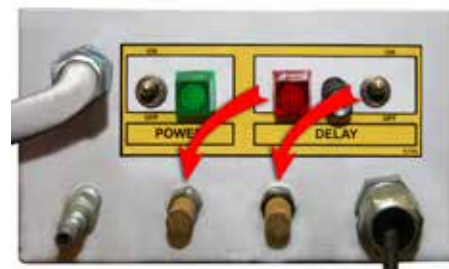
Airline Mufflers MF04

4. Remove the airline mufflers (MF04) from the back of the control box. Check to make sure these are not plugged or restricting the air flow. While these are removed, operate the chute several times. This will allow full air flow to pass through the valves and clear any debris that may be caught inside the valves themselves.

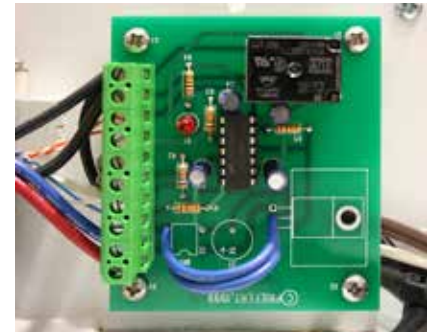
RCBOARDDC

**Problem:** When the control box is in delay mode the laundry solenoid (SOLENOIDL-P) stays activated.

**Solution:** *The delay board (RCBOARDDC) needs to be replaced.*

**Note:** When replacing the delay board, change wire for wire one at a time.

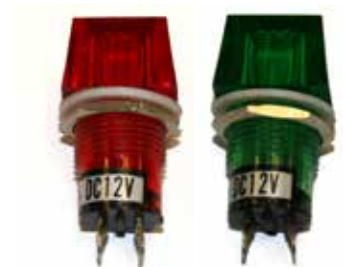
**Solution:** *The lamps should be replaced. The green lamp (LAMP12VG) is a power indicator simply showing that the roping chute is on and ready for use. The red lamp (LAMP12VR) shows the delay has been activated and head gate is about to open.*

LAMP12VR

LAMP12VG

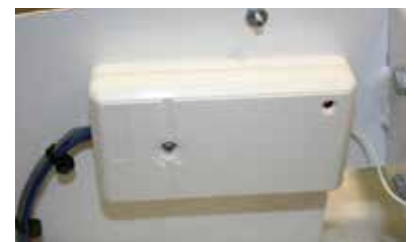
REC2001

*Also, make sure that the antenna is properly installed and not broken. If the problem still exists the receiver (REC2001) may need replacing.*

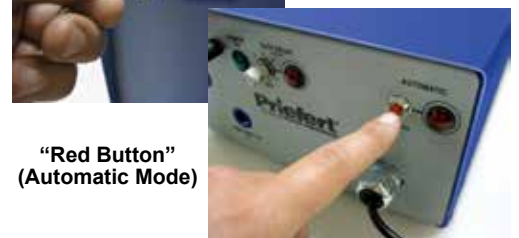
"Red Button"  
(Automatic Mode)

- a. Turn off the power to the control box. The "On/Off" toggle switch is located on the front of the control box.
- b. Push and hold the red button on the back of the control box while turning the "On/Off" toggle switch ON
- c. The two red lights on the back of the control box will start to alternate. Now release the red button.
- d. Press and hold any button on the remote control until the lights stop alternating.
- e. Once the lights stop alternation simply turn the "On/Off" toggle switch OFF and then back on again.

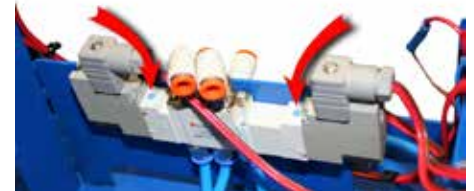
Manual Buttons

1. Make sure the compressor is connected and working properly. We can eliminate this being an air issue by pressing the manual buttons located on the top of each air valve as shown. By pressing these buttons it forces the air valve to function.
2. If the valve will not operate by pressing the button, simply back track your way from the valve to the compressor checking for restricted airlines or lack of airflow from the compressor.

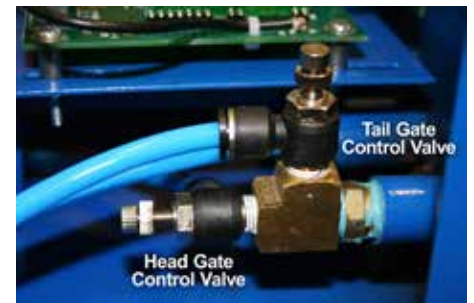
Control Valves

1. Adjust air pressure from the compressor.
2. Adjust control valves to allow more air pressure. These are located just inside the back corner on the control box on the header side.

**NOTE: The control valves may need to be removed and cleaned of debris.**

**The CONTROL VALVE pointing toward the front of the chute is for the head gate cylinder.  
The CONTROL VALVE pointing straight up is for the tail gate cylinder.**

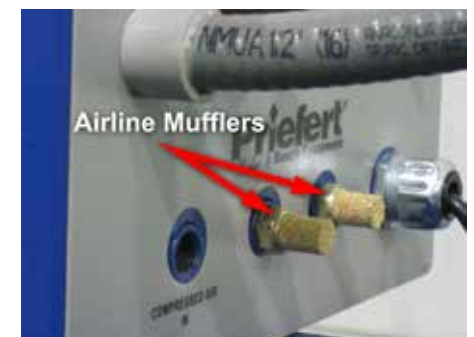
3. Remove the airline mufflers (MF04) from the back of the control box. Check to make sure these are not plugged or restricting the air flow. While these are removed, operate the chute several times. This will allow full air flow to pass through the valves and clear any debris that may be caught inside the valves themselves.

**Header side air muffler - (SY5420-5D-N7T) - RC98AI; RC98ASRAI; RC98ASRAI; RC98ASRAI-CALF**  
**Heeler side air muffler - (SY5120-5D-N7T) - RC98AI; RC98ASRAI; RC98ASRAI; RC98ASRAI-CALF**

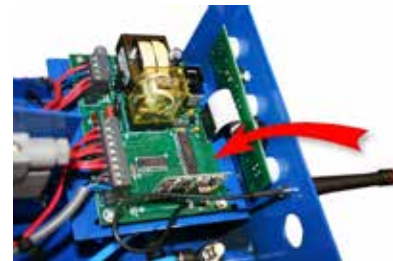
RCGR

**Solution:** *Make sure the battery is good by pressing any button on the remote. The led should be bright and crisp. Next, check to make sure the antenna is installed properly on the back of the control box. If these do not work, the receiver on the circuit board (RCGR) may be faulty.*

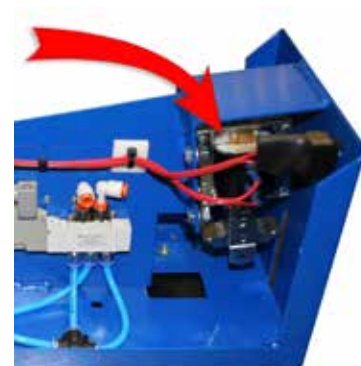
Laundry Solenoid

**Problem:** The trip lever remains in the up position and causes the head gate to bounce back open when the chute is in Photo-Eye mode.

**Solution:** *The laundry solenoid (SOLENOIDL-P) needs to be replaced. A small modification is made to allow the solenoid to drop before the head gate cycle activates.*

**Note:** Make sure the solenoid is not in a mechanical bind and works free by lifting the trip lever up and down easily with your fingers. If the solenoid doesn't operate freely the control box may need some adjustment. To adjust the control box simply loosen the bolts that hold the control box to the center rail of the roping chute. Move the control box to allow the trip lever to work with ease, then tighten the bolts back.

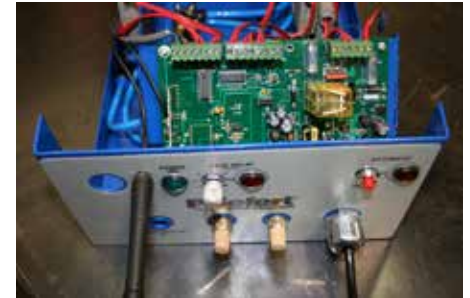
RCGR-SCORE

1. Make sure the battery is good by pressing any button on the remote. The led should be bright and crisp.
2. Check to make sure the antenna is installed properly on the back of the control box. If these do not work, the receiver on the circuit board (RCGR-SCORE) may be faulty.
3. The remote (TRANS2010-RC-SCORE) may need replacing.

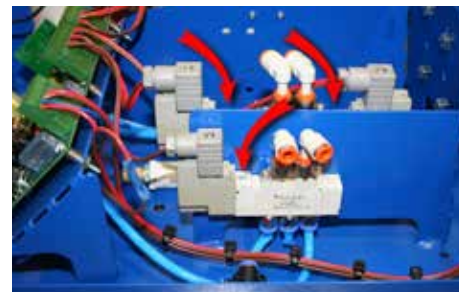
Manual Buttons

1. Make sure the compressor is connected and working properly. We can eliminate this being an air issue by pressing the manual buttons located on the top of each air valve as shown. By pressing these buttons it forces the air valve to function.
2. If the valve will not operate by pressing the button, simply back track your way from the valve to the compressor checking for restricted airlines or lack of airflow from the compressor.

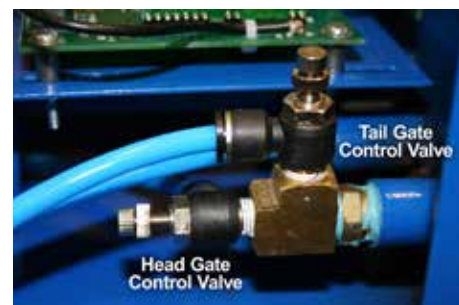
Control Valves

1. Adjust air pressure from the compressor.
2. Adjust control valves to allow more air pressure. These are located just inside the back corner on the control box on the header side.

**NOTE: The control valves may need to be removed and cleaned of debris.**

**The CONTROL VALVE pointing toward the front of the chute is for the head gate cylinder. The CONTROL VALVE pointing straight up is for the tail gate cylinder.**

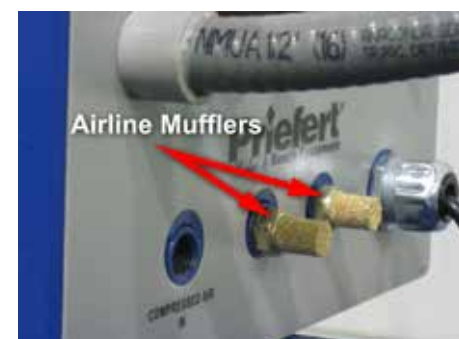
3. Remove the airline mufflers (MF04) from the back of the control box. Check to make sure these are not plugged or restricting the air flow. While these are removed, operate the chute several times. This will allow full air flow to pass through the valves and clear any debris that may be caught inside the valves themselves.

**Header side air muffler - (SY5420-3D-N7T) - RC98SCOREAI**

**Heeler side air muffler - (SY5120-6D-N7T) - RC98SCOREAI**

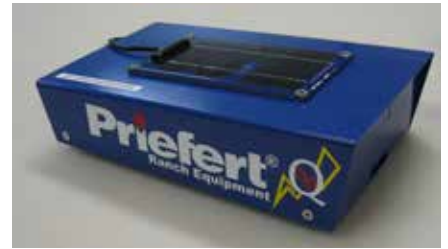
Q36 Solar Panel

1. Make sure the battery is good by pressing the button on the remote. The led should be bright and crisp.
2. Turn the power switch off and back on to clear the system.
3. Make sure the Solar Panel is clean and dirt-free. The panel must be able to get full sunlight to charge the internal battery. If necessary, clean the solar panel with a damp cloth and allow the sun to charge the internal battery for 8-10 hours, then try again.
4. Remove the cover and check to see that the battery is connected. It is sometimes necessary to disconnect and reattach the spade connectors to insure a good electrical connection.
5. The remote (*TRANSQ36*) may need replacing. When replacing the Q36 remote, follow the programming instructions included with the remote.
